11th TPM NATIONAL CONFERENCE – KAIZEN COMPETITION FOR “KAIZEN CHAMPIONSHIP TROPHY”

TITAN INDUSTRIES LIMITED

**Watch Division
(Assembly department)**

**Eliminate Magnetic Screen miss (MS)
defect at Final Inspection stage**

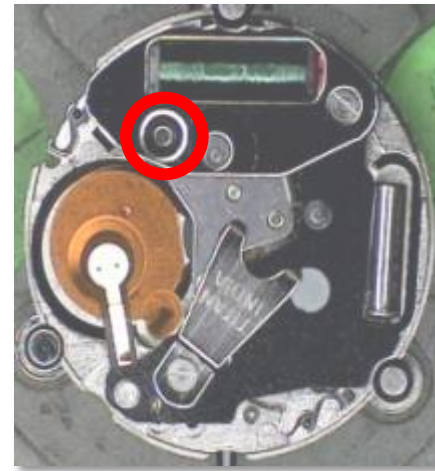
DEFECT

With out MS screw

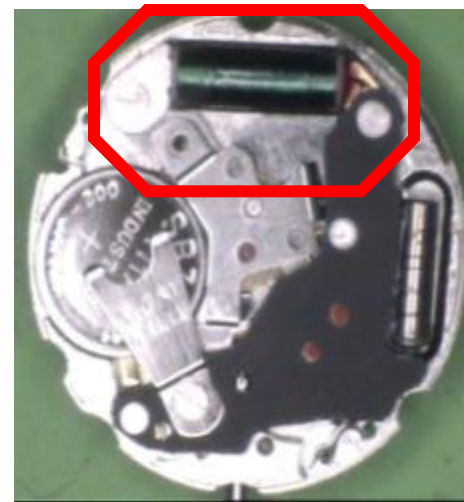
DEFECT

With out MS & screw

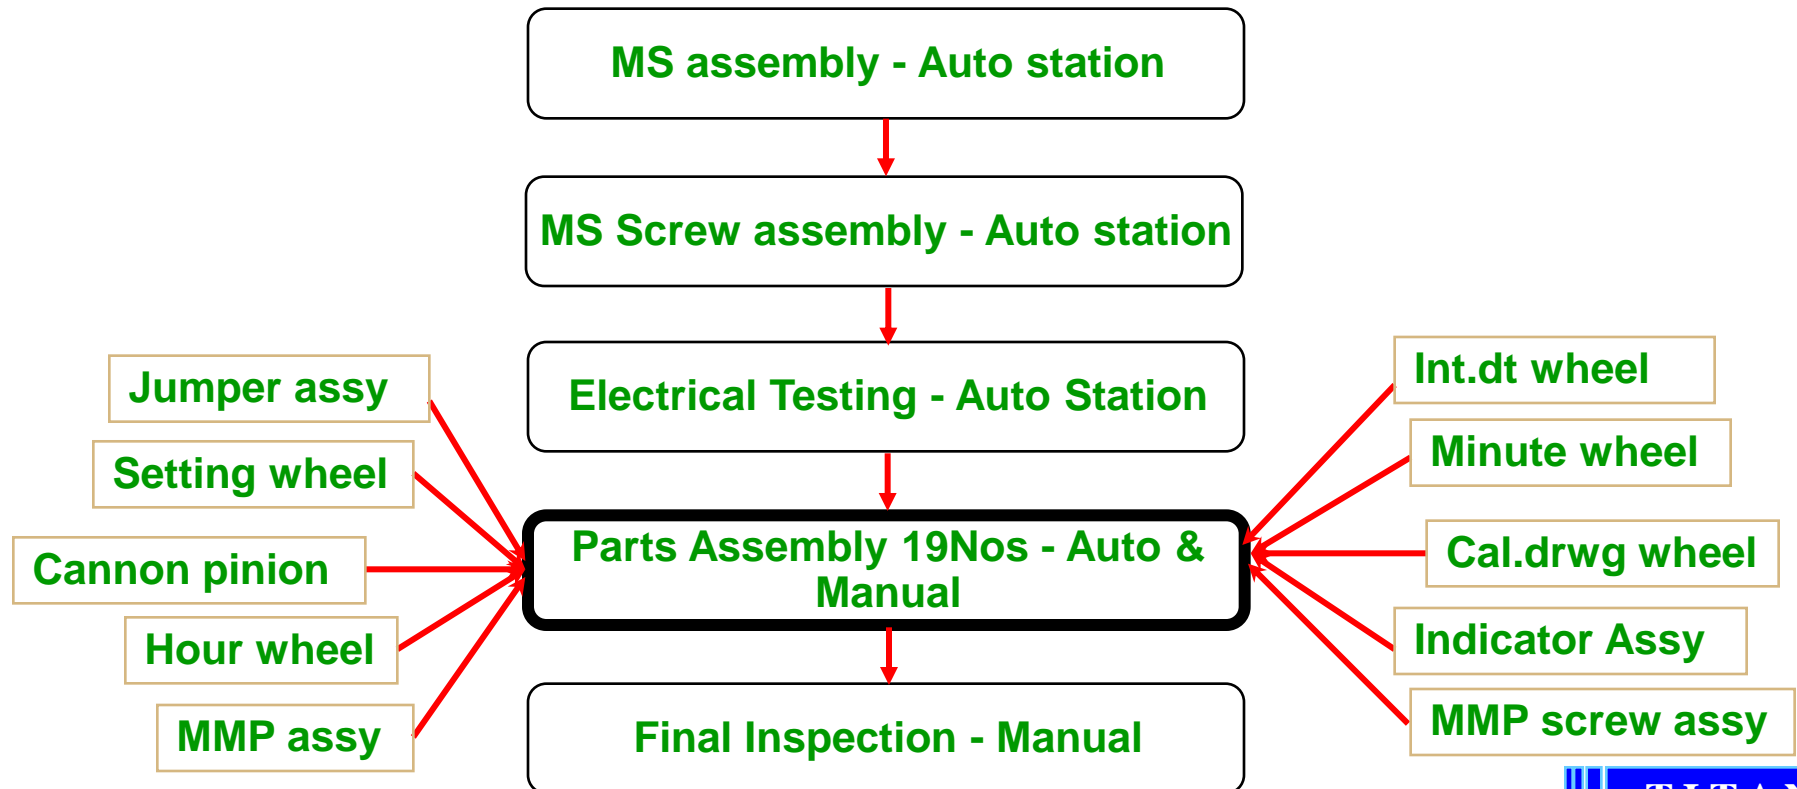
PROBLEM PRESENT STATUS

1. “MS miss defect” is detected at the manual inspection stage after the complete movement assembly with 43 components
2. The rework was around 5000 PPM
3. When screw is wrongly assembled, movements were passing without MS.
4. MS assembled with improper position also got accepted at electrical testing. Since, the probing is at ECB screw. (No poke-yoke)

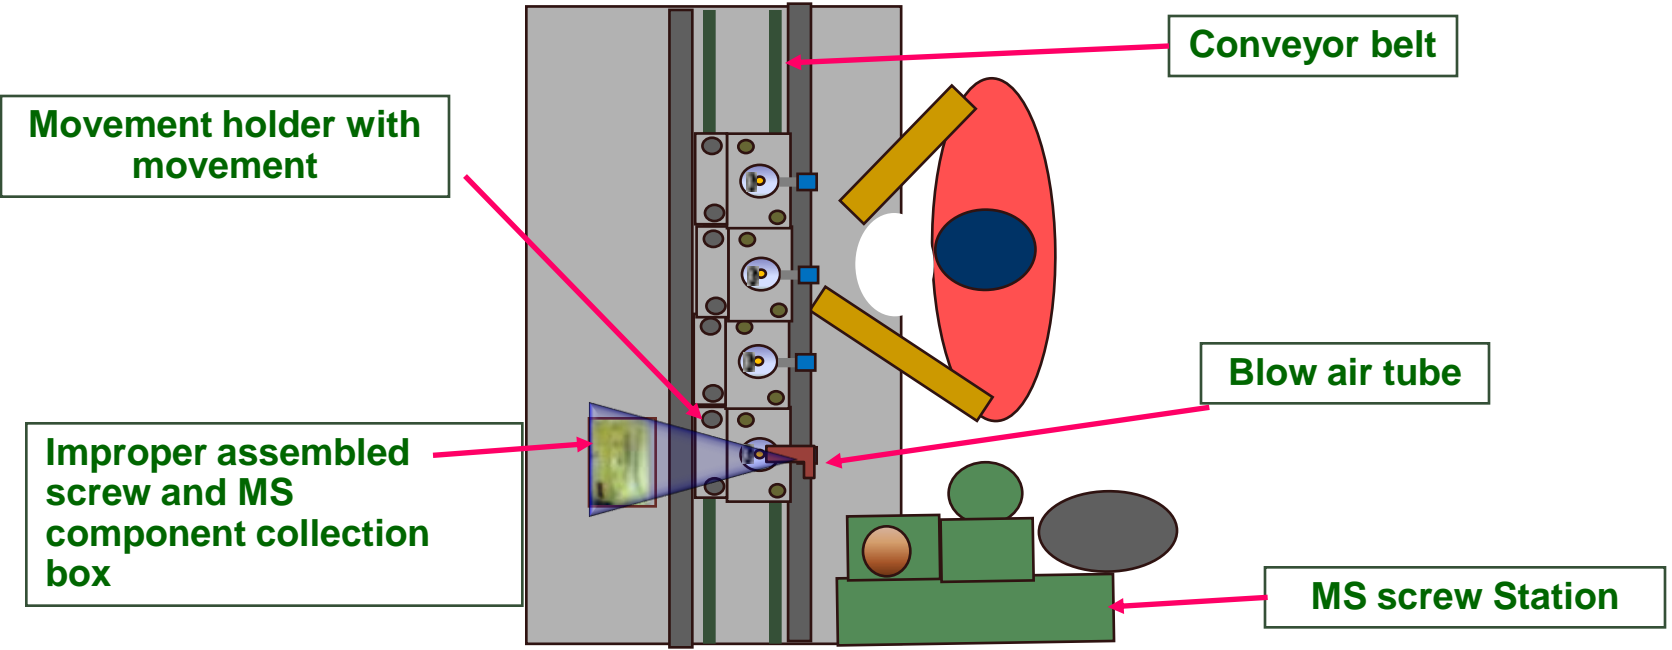
PROVIDING IMPROPER MS ASSEMBLY COMPONENT COLLECTION BOX

When screw is wrongly assembled or Improper MS assembly components will fall on floor at various place.

- ❑ Blow air provided next to MS screw station to collect the Improper assembled screw and MS component
- ❑ One collection box positioned opposite to the Air tube.
- ❑ Blowing air provided at the surface level of MS (Vertical height)

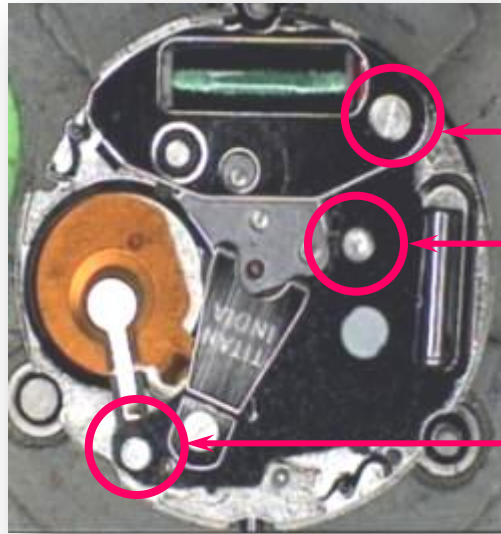
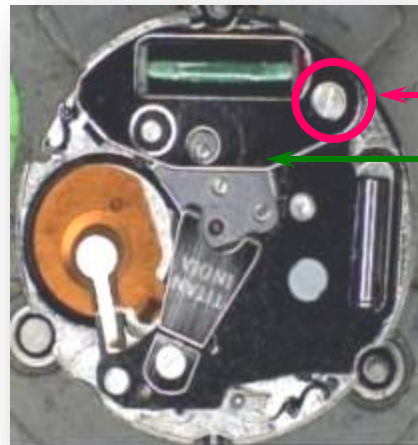
IDENTIFYING DETECTION POINT FOR MS MISS

- Magnetic Screen also as a Positive contact area in movement.
- Detection point changed from ECB Screw place to MS place.
- To detect MS component, Identified non affected area of MS

Poke- yoke system

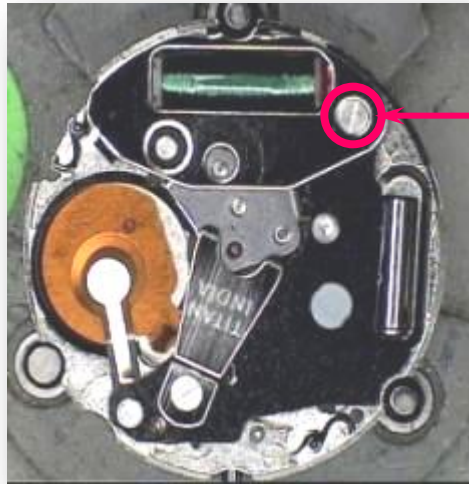
Before

Checking pin position

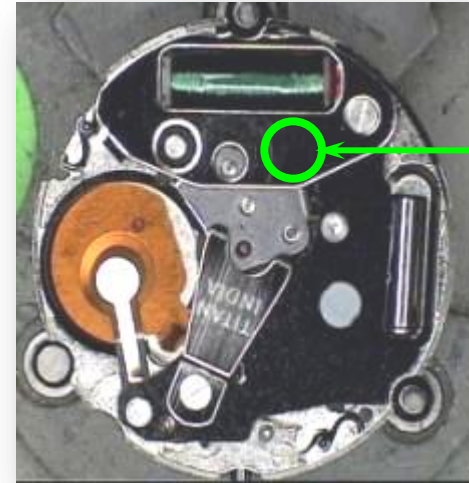
After

Checking pin position

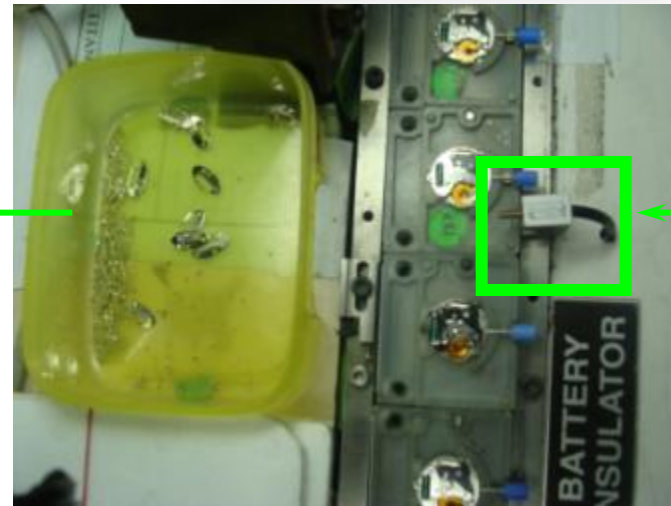
MS & Screw collection box

Blow air tube set
